***A new addition to the Philips “intelligent drive” features, Seamless Link acts to manage and minimise the effects of buffer under run (BUR), a common cause of wasted discs during the CD writing process.***

# ABOUT BUFFER UNDER RUN (BUR)

# HOW SEAMLESS LINK WORKS

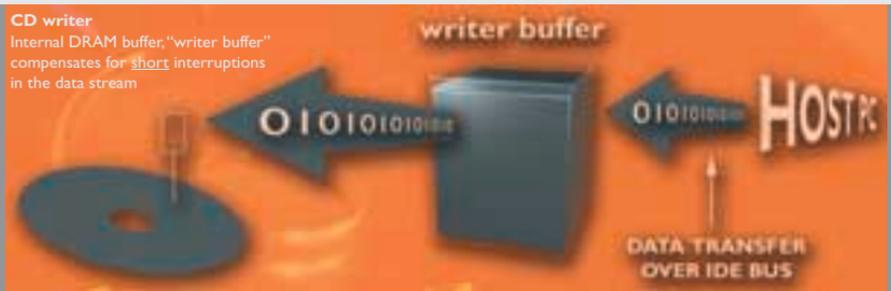
Fig. 1, Typical CD writing process: The data that needs to be written on the disc is transferred from the source over the system bus, and is put into the DRAM buffer of the CD writer. From this buffer, the data is put onto a disc in the writing process.

Buffer under run can occur when the users' PC or a host PC cannot supply a steady and uninterrupted flow of data from the data source, typically a CD ROM or HDD, to the internal DRAM buffer of the CD writer (writer buffer) (Fig. 1). If this transfer of data to the drive writer buffer is interrupted, then the buffer is not kept full (Fig. 2). If the interruption is long enough, the "writer buffer" gets empty, the writing process stops and the disc is ruined (Fig. 3). Buffer under run occurs most frequently when users are writing to a CD-R or CD-RW disc in either Track-at-Once (TAO) or Disc-at-Once (DAO) mode.

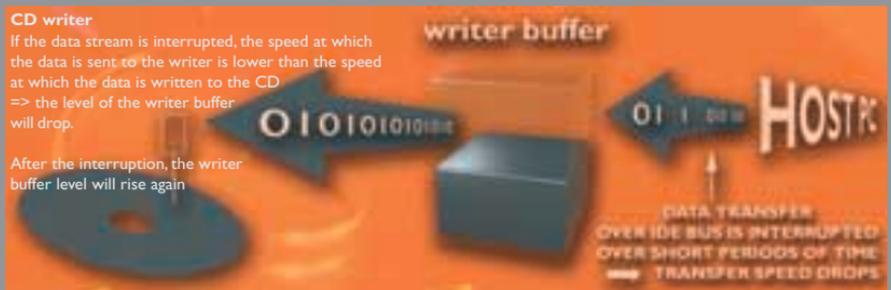
Fig. 2, Typical CD writing process: Short interruptions in the transfer of the data over the IDE bus will cause the writer buffer level to drop.

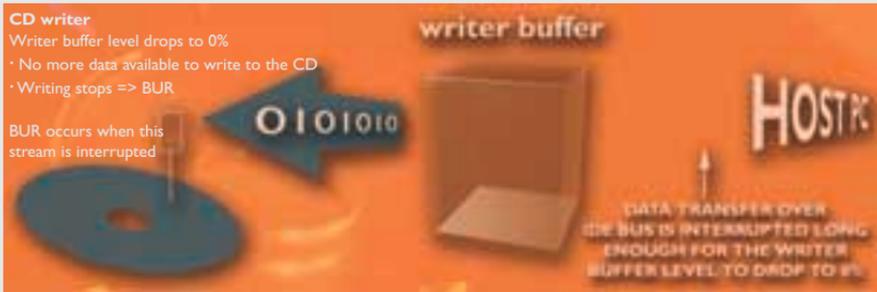
Fig. 3, Typical CD writing process: Buffer under run occurs and results in writing failure, disc is ruined.

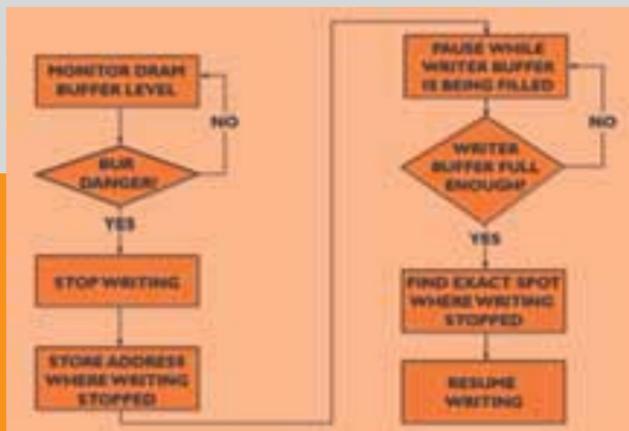
Fig. 4, The Seamless Link algorithm:

The Seamless Link algorithm (Fig. 4), constantly monitors the writer buffer level. If the writer buffer level drops below a threshold value, the algorithm concludes that a BUR is imminent and stops the writing process in a controlled way. This means that the data stream from the buffer to the disc is halted, and allows the buffer to be filled up again.

The exact location where the writing stopped is stored in the drive's internal memory. In the meantime, the buffer level is continuously monitored and as soon as the buffer is full again, the algorithm will let the drive seek to the location where the writing stopped. It then resumes the writing process as soon as the laser is on the exact spot where the writing stopped. This type of writing eliminates the gap, which occurs between two individual writing operations during traditional writing. Hence the name Seamless Link.
